The Equipment & Techniques Committee

Eco and BP anchor long term test bed anchor placement report 20th October 2012

Location: Yordas gorge, West Kingsdale, North Yorkshire NGR: SD705792

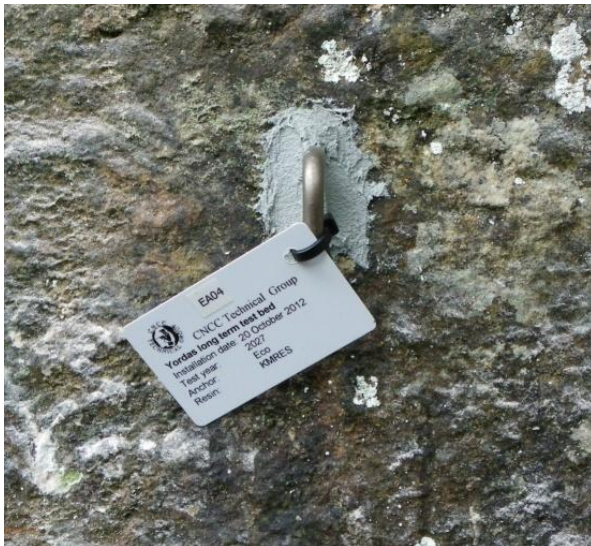
Example of Eco placement

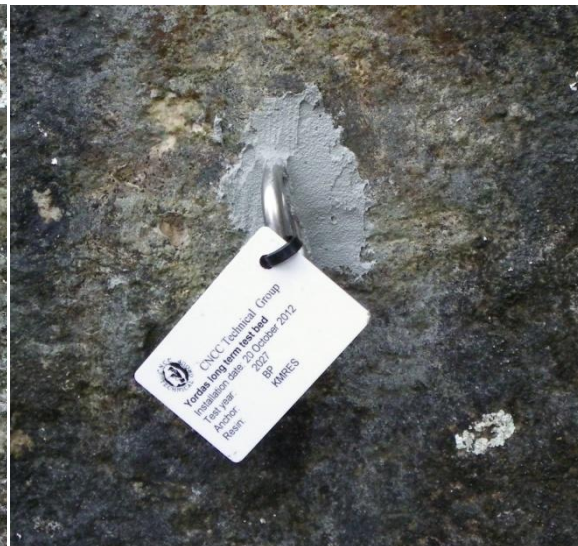
Example of BP placement
