The Equipment & Techniques Committee

Eco anchor long term test report 13th October 2012

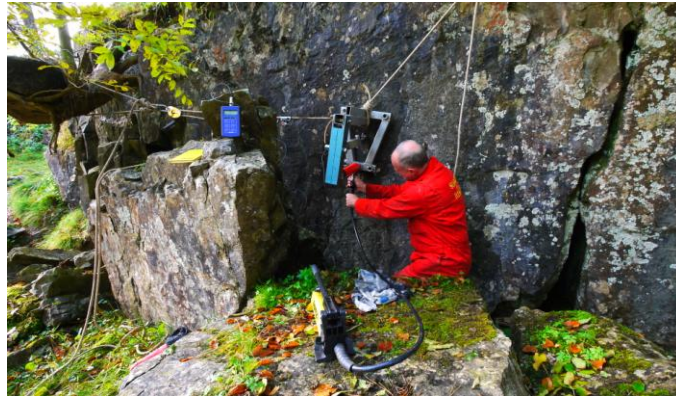
Yordas Gorge NGR: SD705792. The block of limestone is in an area that has vegetation growing in close proximity, the whole area is very damp and subject to periodic flooding. In winter the anchors will be under ice and therefore subjected to cycles of freeze and thaw. The anchors were installed so that a test rig could be suspended beneath a tree and pulled into place by a transverse tensioned rope. This would also allow for the rig to remain suspended while the anchor was being extracted from the substrate.

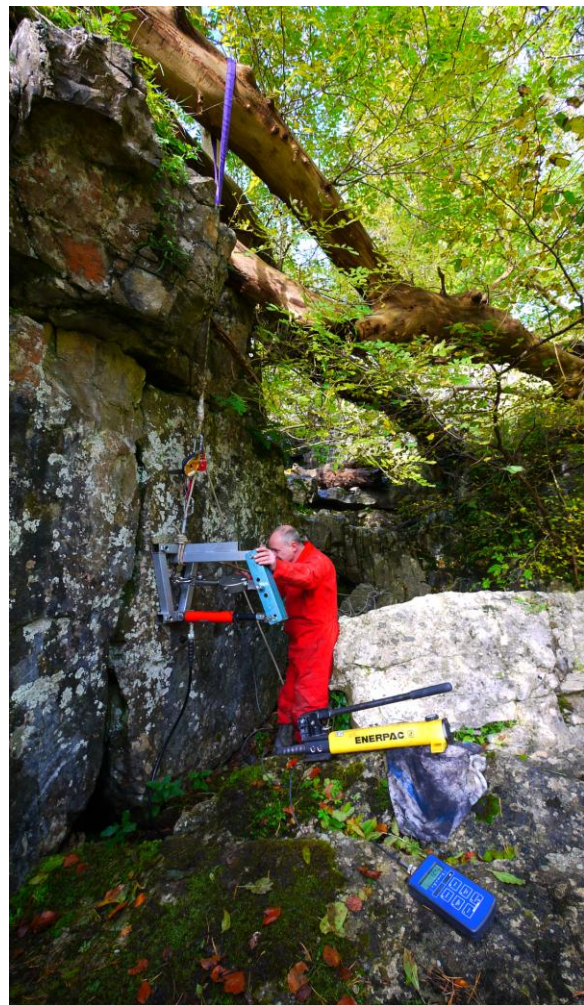
In March 1998 eight Eco anchors were installed horizontally into a block of mass limestone using Resifix 3+ chemical anchor mortar batch reference M277. The correct method of installation as defined in the document Permanent Resin Bonded Anchor Installation Guidelines 01.01.1998 was used. The placements were chosen at random as would be the case when installing anchors underground.

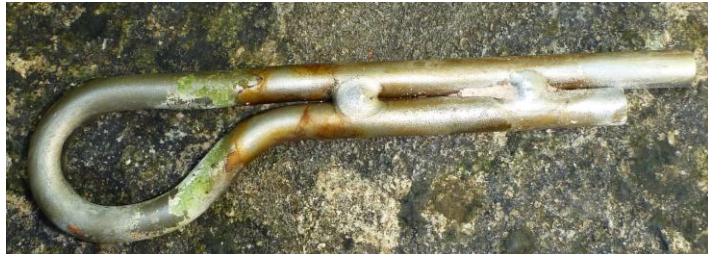
All the anchors had signs of light surface rust staining along the shafts of the anchors. Anchor placement TB105 was proud of the substrate by about 2mm; this protrusion affected both the resin plug and the anchor. As there were no

obvious signs that the anchor had been interfered with it may be that water ingress had occurred at some point in time and with freezing the placement moved outwards. The anchor does exhibit a discolouration the full length of its shaft. After extraction the holes was re-drilled, washed, brushed and dried. The hole was inspected using an inspection probe and the following observations were made; a small fissure radiating around the hole at about 75mm depth was visible. There was also a very small horizontal surface fissure that was on the left hand side of the hole and entered the hole for about 20mm. It may be possible that the fissure at 75mm depth may have allowed the ingress of moisture during the placement period of 14 years.

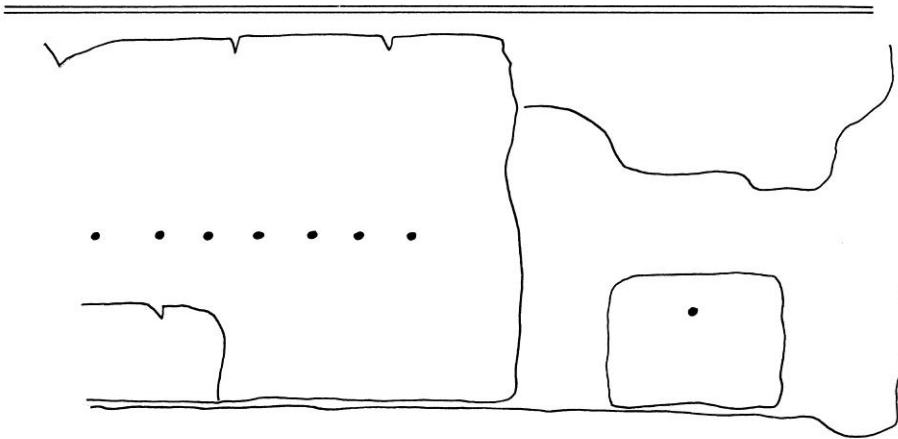
Eco anchor Gorge test bed from left to right

TB101

TB102

TB103

TB104

TB105

TB106

TB107

TB108
